Manhole Inspection Summary

Manhole # **S13GG_054MH**

Location Address: **2900 BRIGHTON ST** Cross Street: **POPLAR GROVE ST**

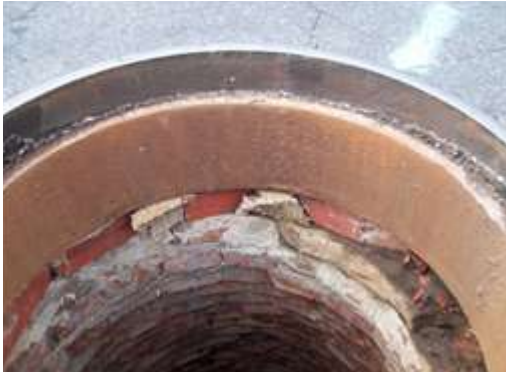
Defect 2

Chimney / Frame Adjustment ☒ Exists Material: **Brick** ☐ Parged Height: **4** (in.)

Condition: ☐ Sound ☒ **Cracked** ☐ Root Intrusion ☐ Loose Brick ☐ Deteriorated

CRACKED CHIMNEY

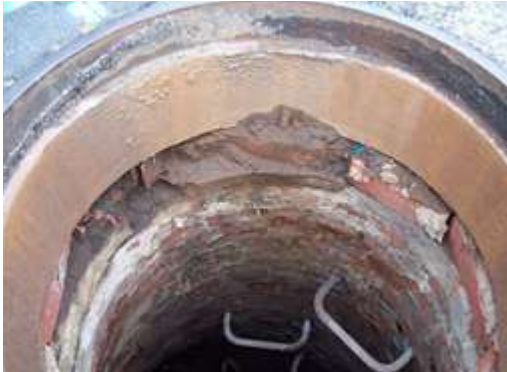
Defect 1

Frame Offset: **2** (in.) Condition: ☒ Sound ☐ Cracked ☐ Leaks

FRAME OFFSET

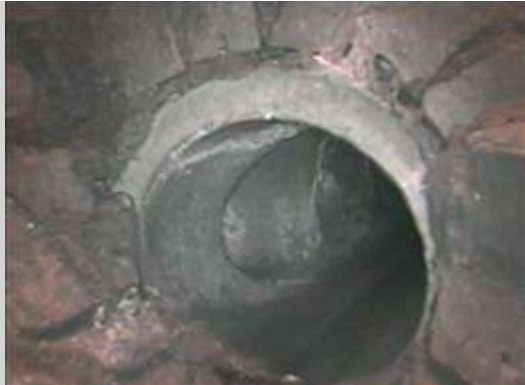
12 O'Clock Outflow

8 in. Circular Gravity Sewer
Pipe Out @ 12 O'Clock

Pipe Material: **Clay** ☐ Pipe Lined

Invert Depth: **8.50** (ft.) Flow Characteristics: **Slow**

Infiltration: **None** Pipe Seal Cond: **Sound**

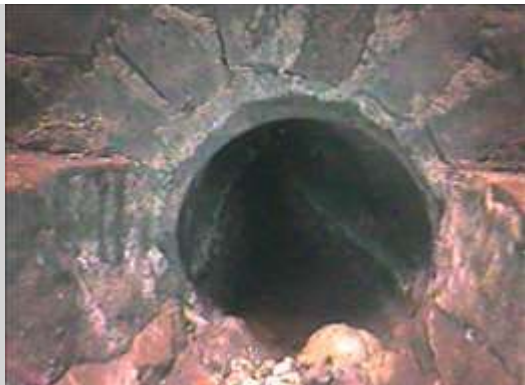
4 O'Clock Inflow

8 in. Circular Gravity Sewer
Pipe In @ 4 O'Clock

Pipe Material: **Clay** ☐ Pipe Lined

Invert Depth: **8.46** (ft.) Flow Characteristics: **Slow**

Infiltration: **None** Pipe Seal Cond: **Sound**

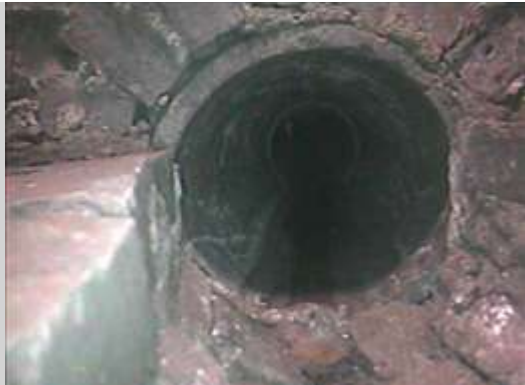
6 O'Clock Inflow

8 in. Circular Gravity Sewer

Pipe In @ 6 O'Clock

Pipe Material: **Clay** ☐ Pipe Lined

Invert Depth: **8.41** (ft.) Flow Characteristics: **Slow**

Infiltration: **None** Pipe Seal Cond: **Sound**

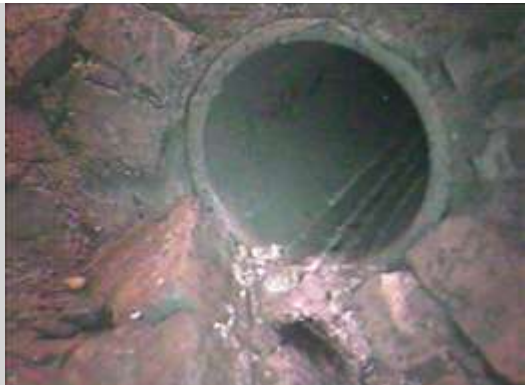
10 O'Clock Inflow

6 in. Circular Gravity Sewer

Pipe In @ 10 O'Clock

Pipe Material: **Clay** ☐ Pipe Lined

Invert Depth: **8.20** (ft.) Flow Characteristics: **Slow**

Infiltration: **None** Pipe Seal Cond: **Sound**

Connects To: **House connection / Service line**
